OMNISEC SOFTWARE: v10.41 (PSS0051-07) SOFTWARE UPDATE NOTIFICATION

Introduction

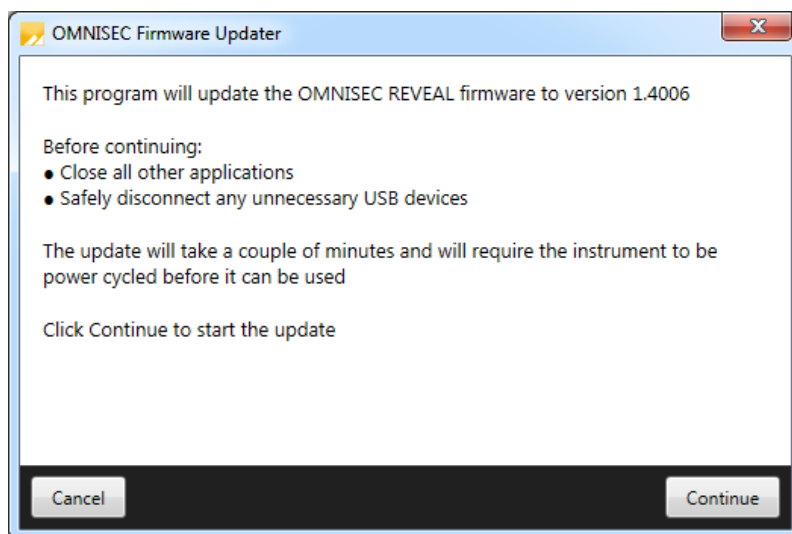
When the OMNISEC Firmware Updater launches, you should carefully read the information presented to you before continuing.

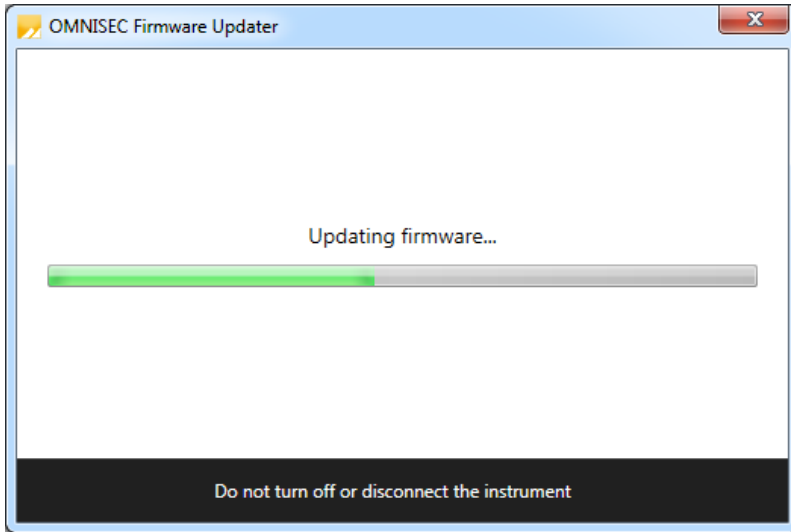
The update process takes several minutes. It is recommended that you do not do anything else on your computer during the update.
