# MORPHOLOGI SOFTWARE: v10.32 (PSS0065-07) SOFTWARE UPDATE NOTIFICATION

## Introduction

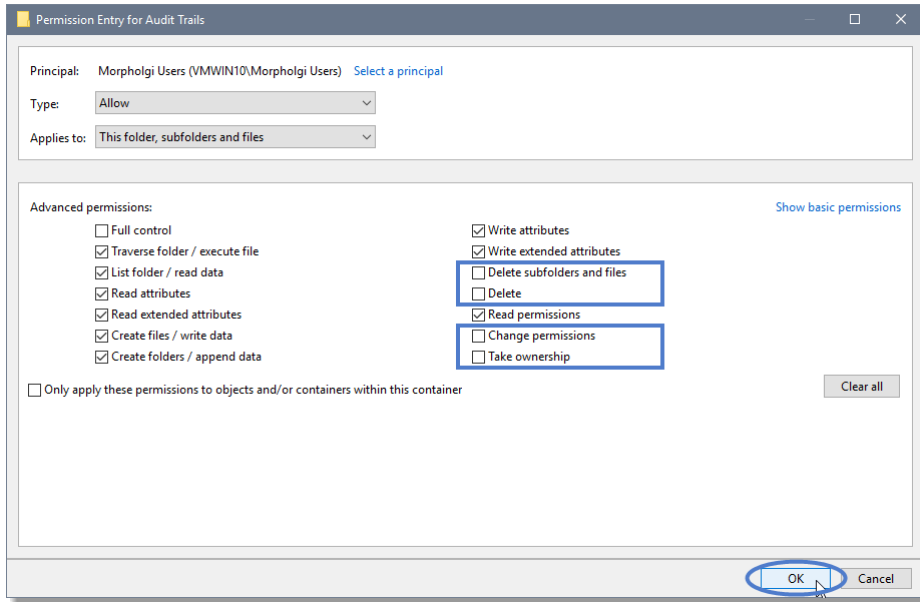
8. Left-click **Replace all child permission entries with inheritable permission entries from the object** and left-click the **Apply** button.

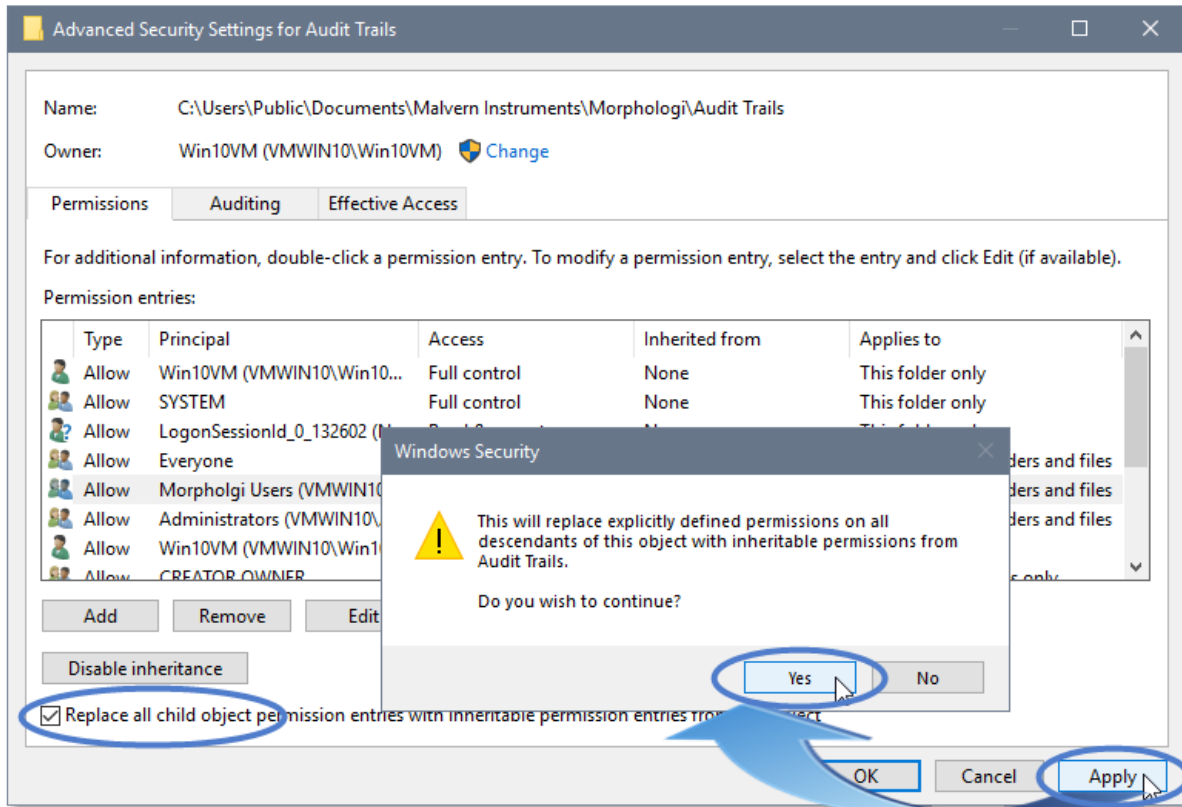
10. Left-click the **OK** button when you return to original folder properties window.
