# Software Update Notification

PSS00002-22: Mastersizer 2000 v5.40 software

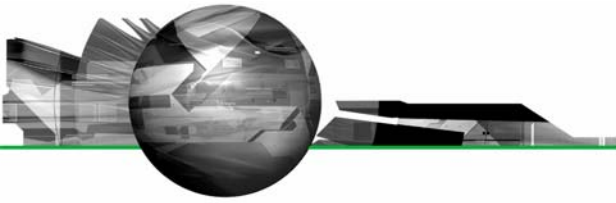
### Instrument compatibility

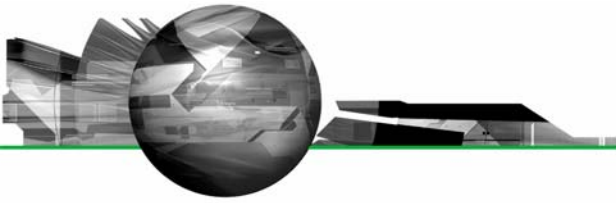
SCR Number	Description	Comments
6216	The documentation page should be displayed before the optical background is taken to prevent large delays between the background an measurement.	(Implemented issue 22)
6240	When entering a new source or bulk lot label in a manual measurement; new values should be added to the list.	(Implemented issue 22)
6299	The firmware update was not robust against changes to the kernel flash programming algorithm. This could lead to corrupt firmware on the accessories.	(Fixed issue 22)

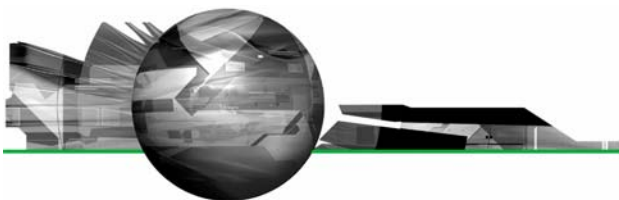
There are no known bugs in this version of the Mastersizer 2000 software. If you suspect that you have found a bug then please contact Malvern Instruments detailing all aspects of the symptoms observed.

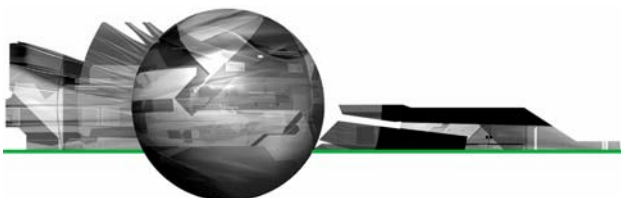
the analysis, especially for those samples where the Dv100 value was always reported to be 2000µm. Testing has shown, however, that the shift in the reported values for percentiles below the Dv99.5 is negligible.
